Draft Final Report • National Institute of Standards and Technology (NIST)

of the May 22, 2011,
Tornado in
Joplin, Missouri

NIST NCSTAR 3 (Draft)

November 2013

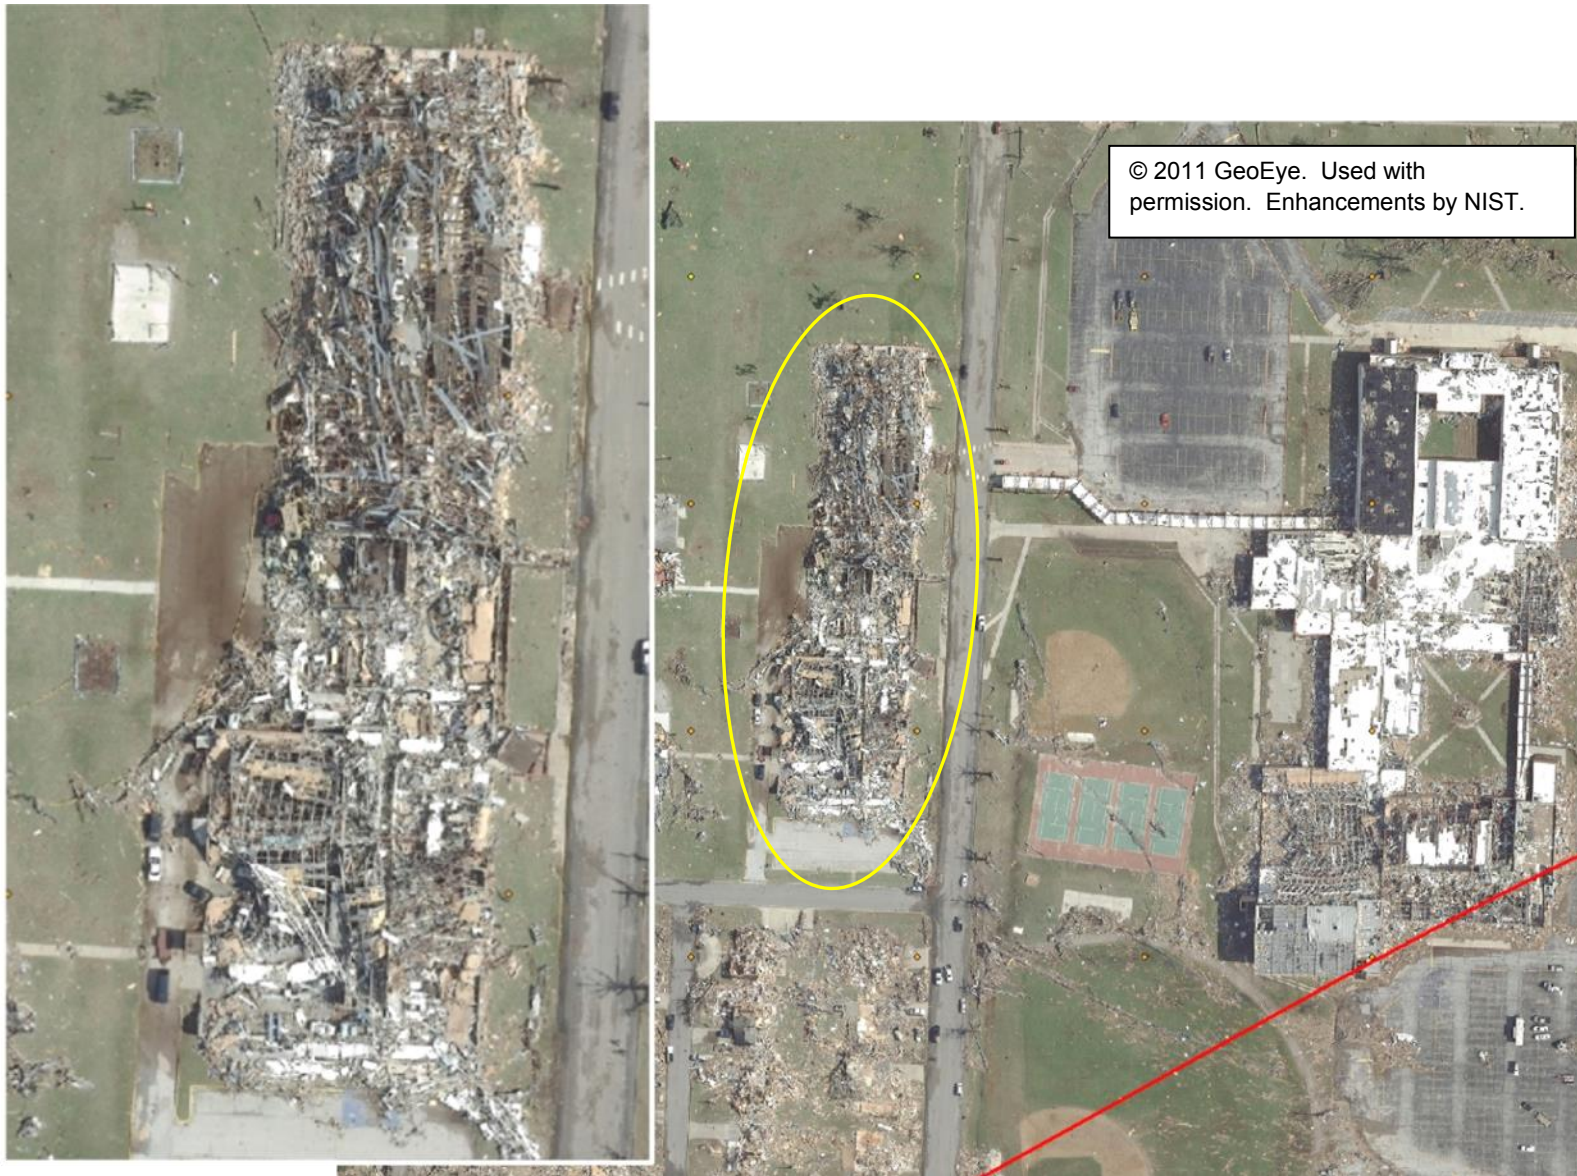
Figure 3–74. Overview of damage at Franklin Technology Center, with center line of tornado damage path (in red).

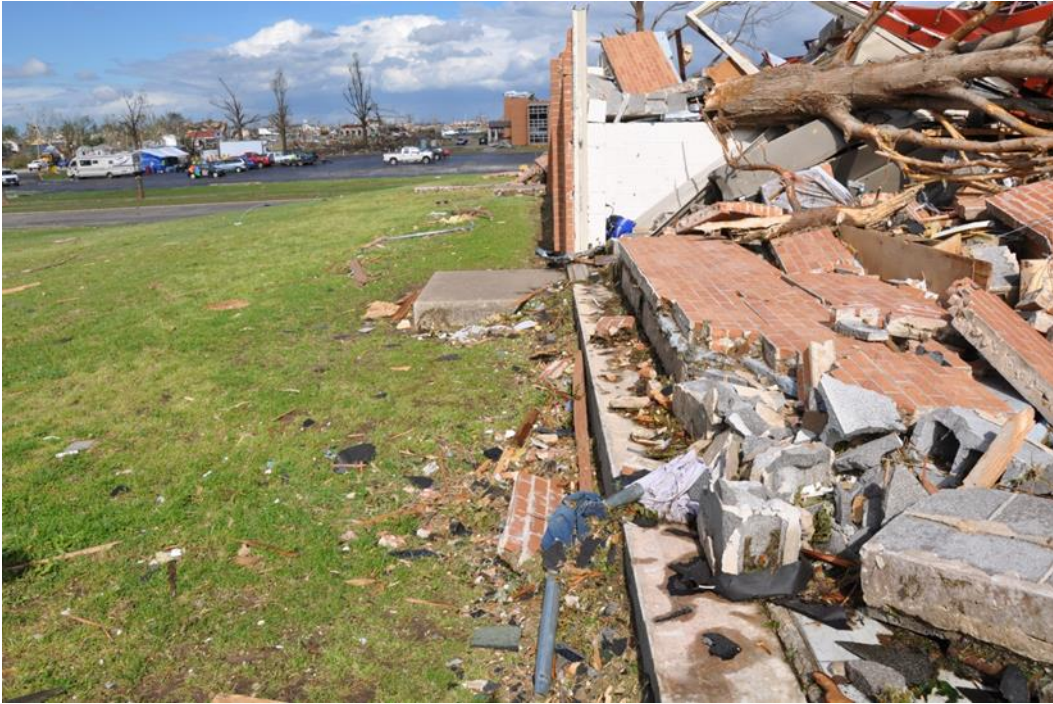
Figure 3-78. Perimeter CMU wall that collapsed after loss of roof lateral bracing (note lack of reinforcing dowels connecting wall to concrete footing).

- Almost all of the perimeter CMU walls collapsed. It should be noted that while the walls were partially grouted and reinforced, as specified in the available design information for the 1978 south-half addition, close inspection on May 25, 2011, found that there were wall sections (especially in the original 1960s north half) that had no or minimal structural connection between the wall and the RC foundation⁸⁶ (see Fig. 3–78 and 3–79).

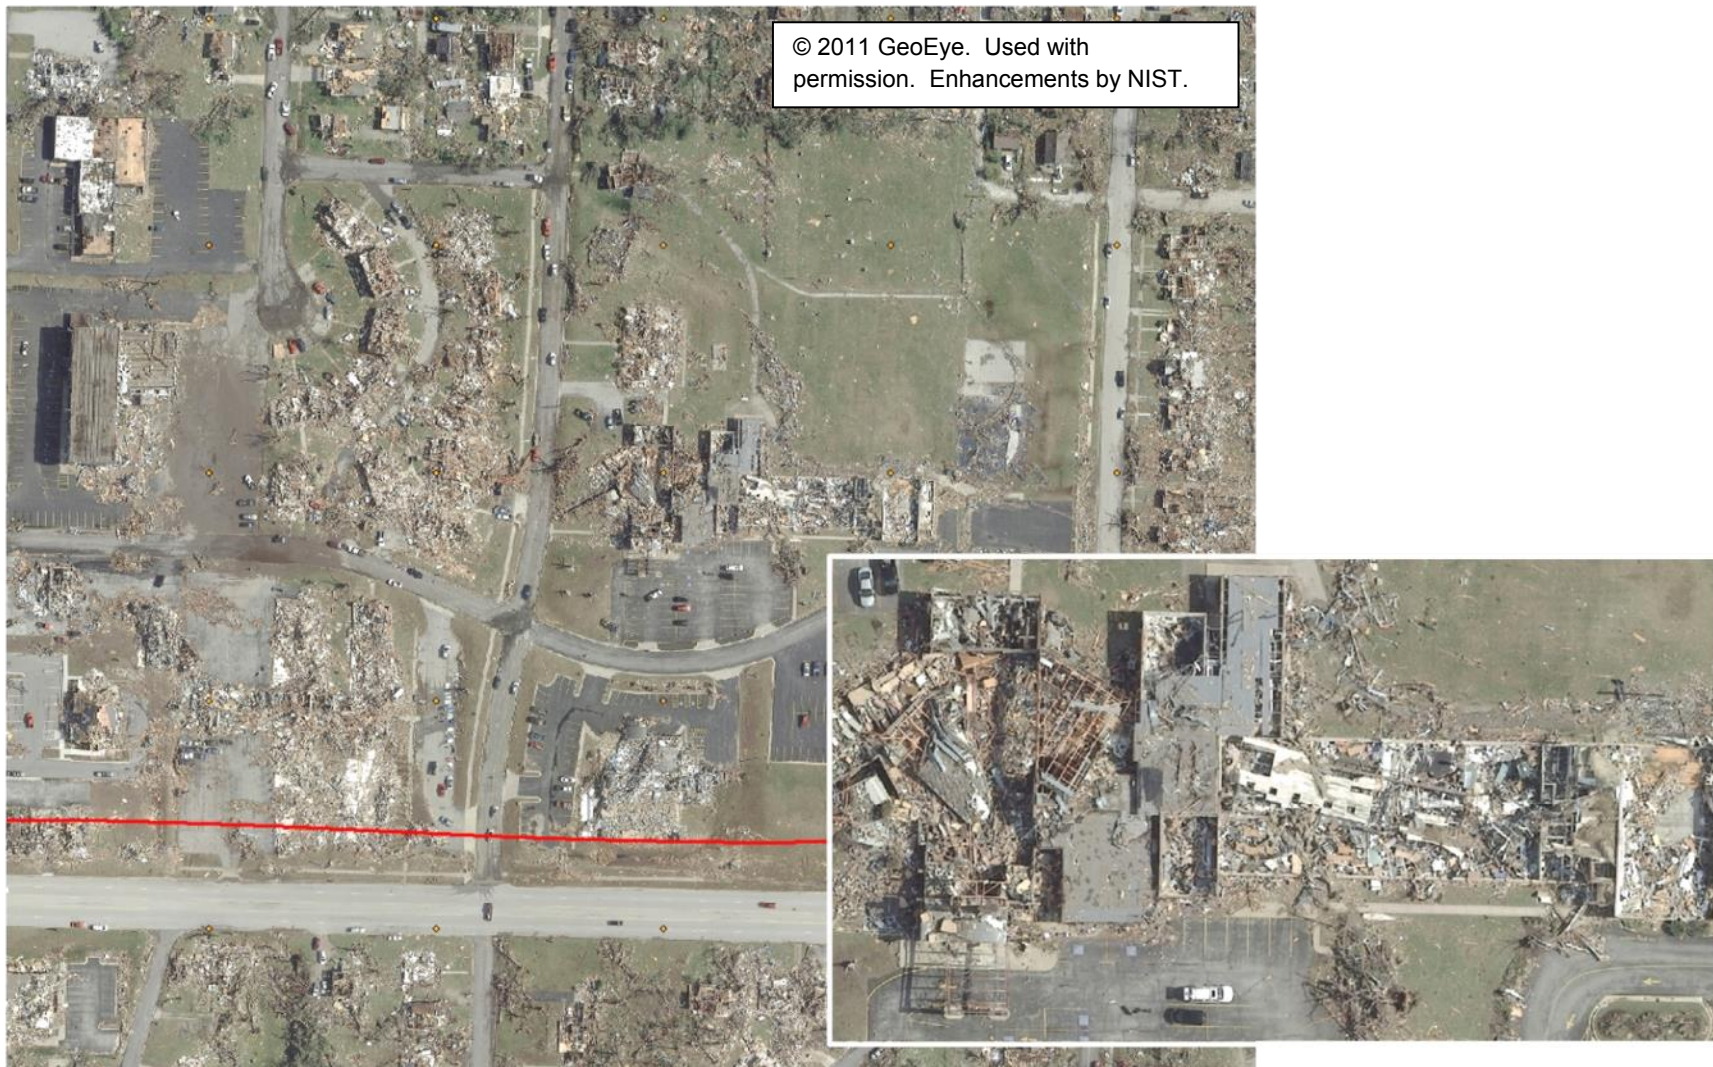
Figure 3–80. Overview of damage at St. Mary's Catholic Elementary School, with estimated center line of tornado damage path shown in red.

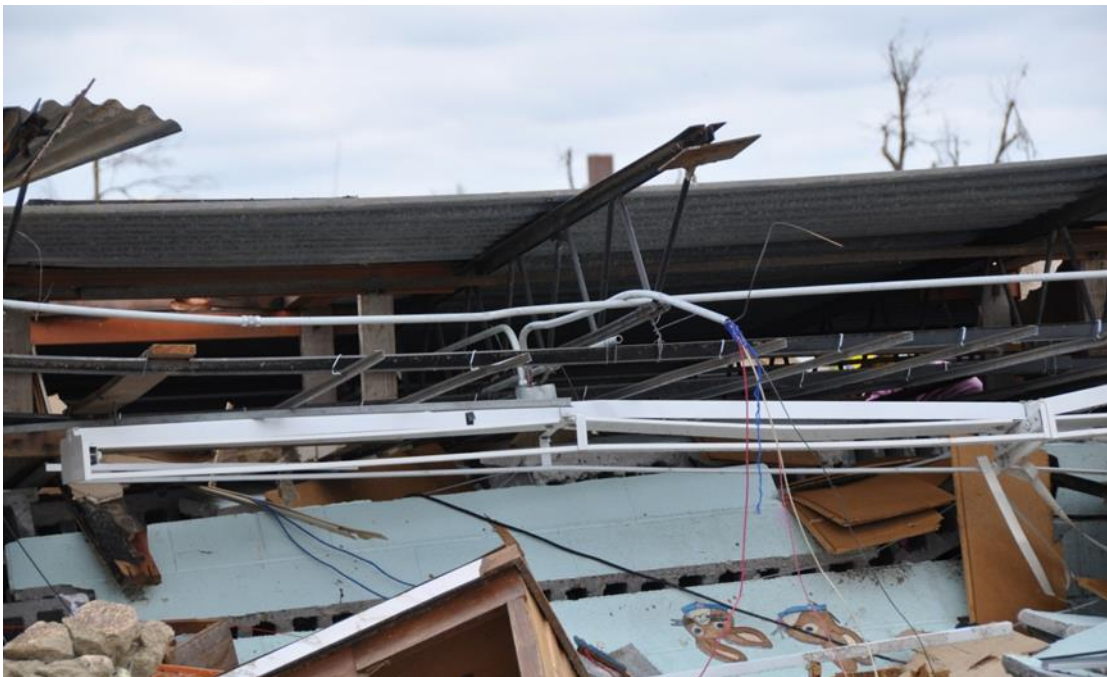
Figure 3–82. Section of building at St. Mary’s Catholic Elementary school with complete loss of the steel roof system.

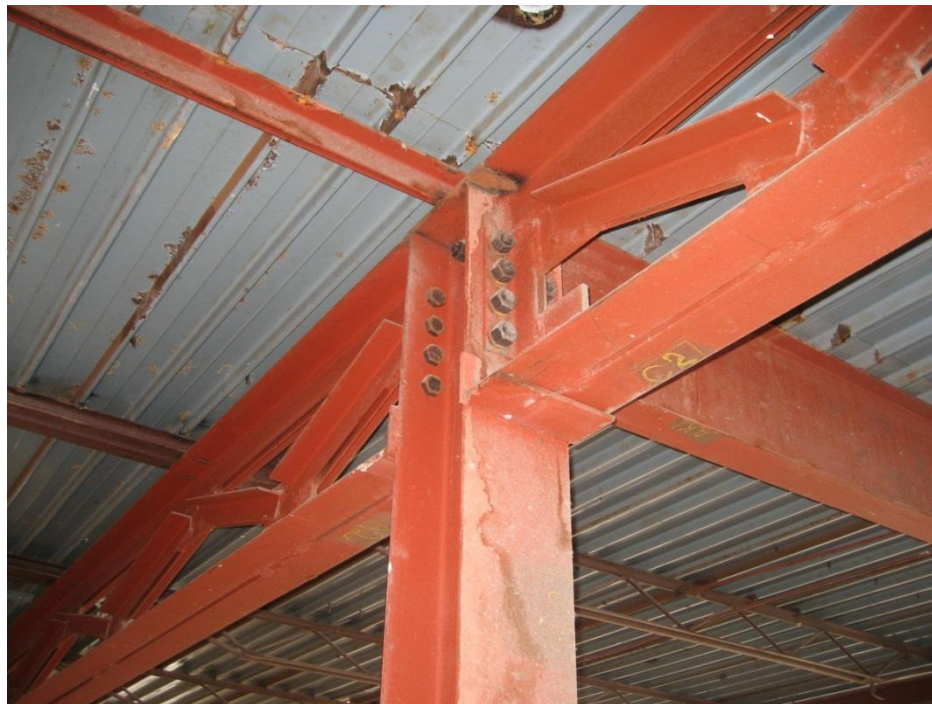
Figure 3–87. Interior view of the physical education section of the Ozark Center showing structural system with roof truss–column moment connection and open–web roof joist and wide–rib steel roof deck.

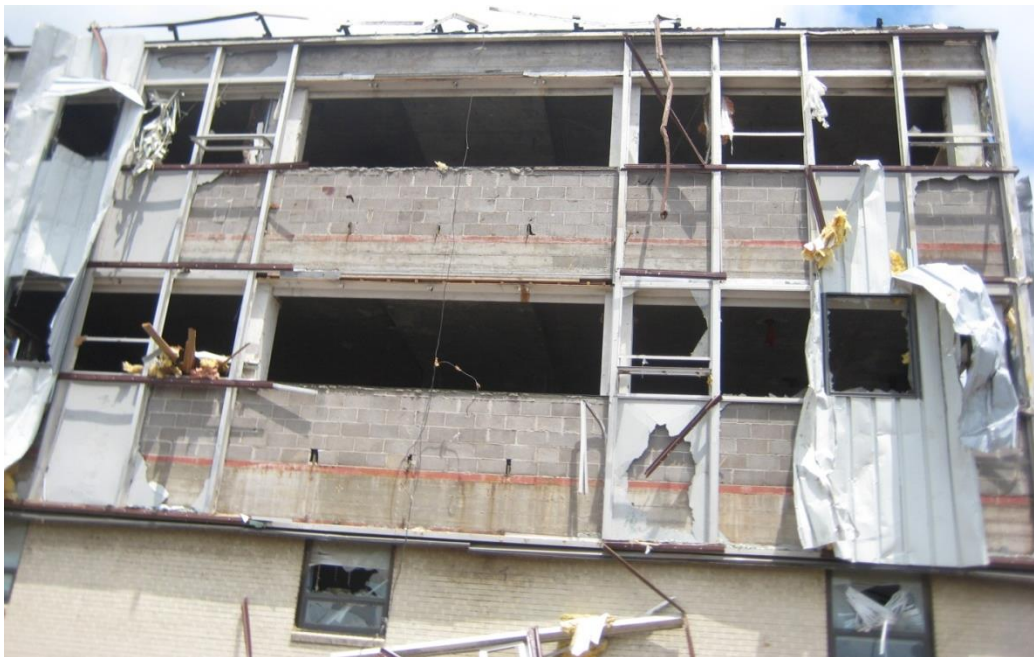
- Loss of part of the roof system (steel roof decks only, not the supporting roof joists) and all vertical envelopes (insulating windows and window frames) on all three wind-exposed sides of the PE section due to wind uplift pressure (disconnection and loss of steel roof decks, see Fig. 3–88).
- Damage to or loss of all vertical envelopes on all four wind-exposed sides of the Main section, including failures of all light-gauge exterior steel panels and window glass glazing (see Fig. 3–89).

Figure 3–89. Typical damage to the Ozark Center building envelope (broken window glazing, missing window frames, and torn exterior steel panels).

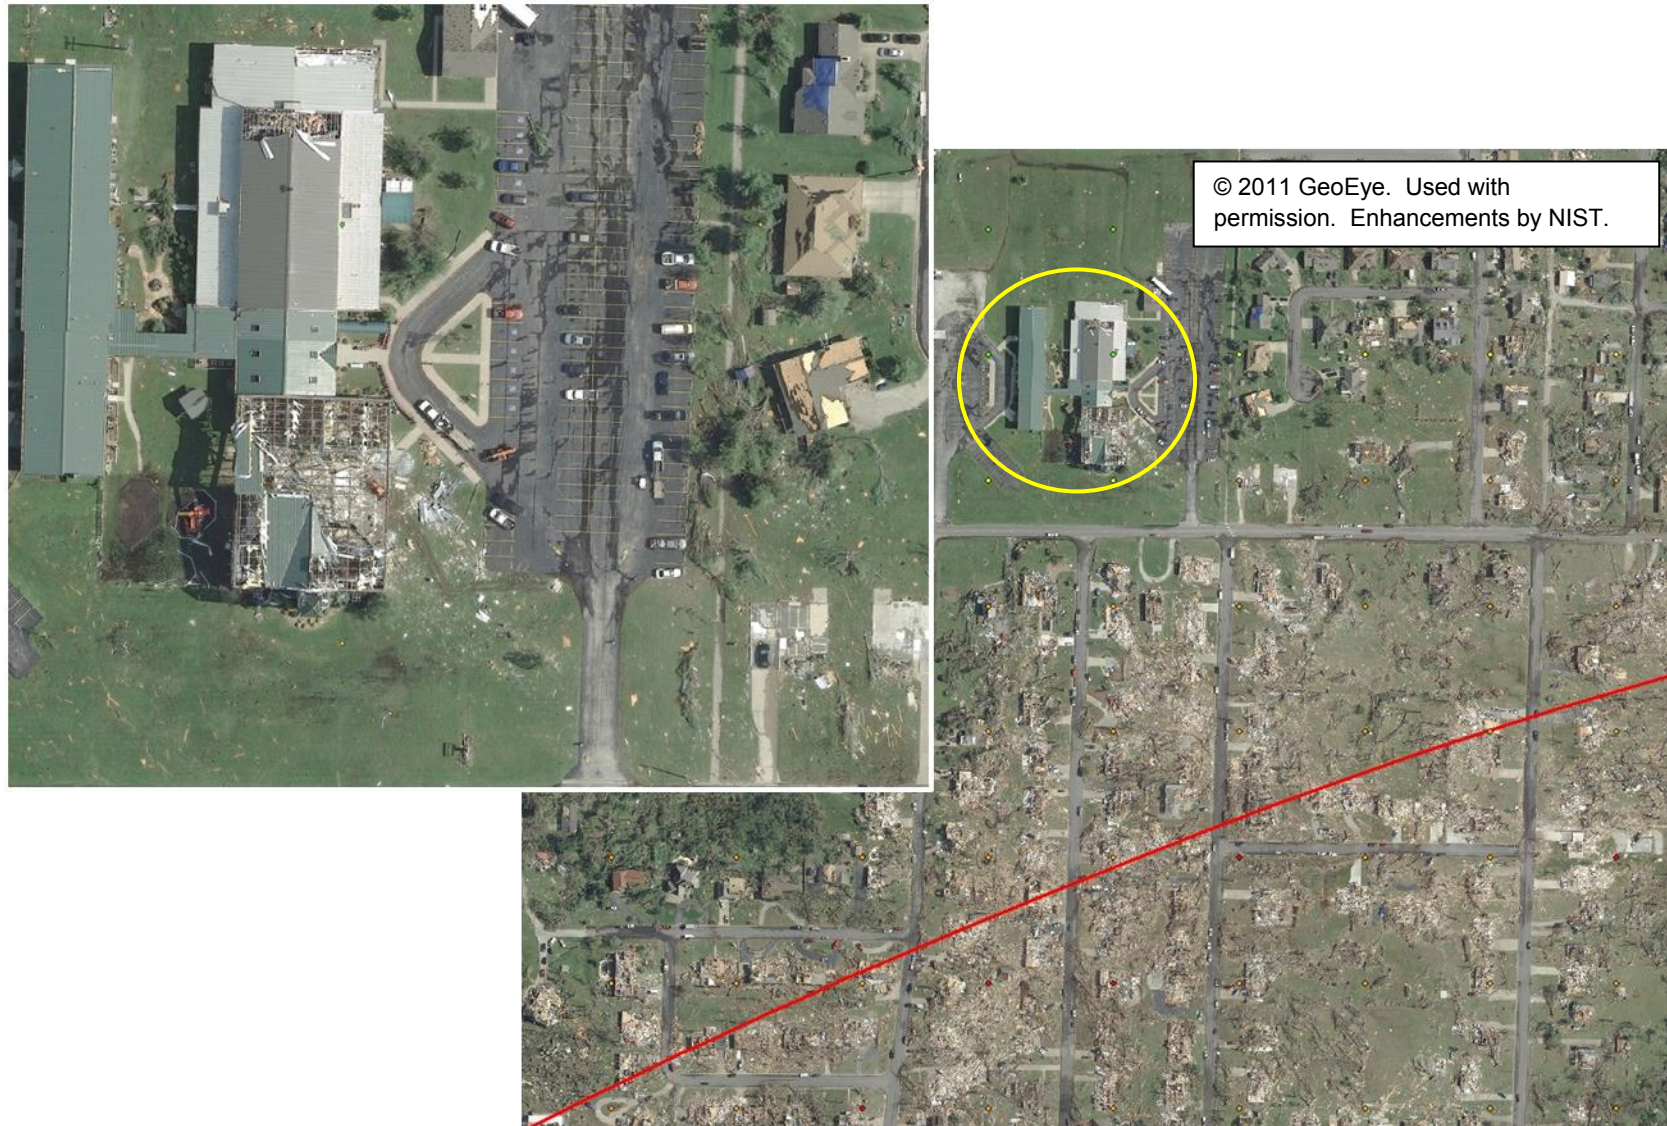
The building sustained significant damage to the envelope (disconnection and loss of all sheet steel roof decks and all vertical sheet steel wall panels, as well as the collapse of part of the steel-stud exterior frames), but only limited damage to the MWFRS (braced primary rigid frames). As a result, the building did not collapse, but sustained complete loss of functionality due to the loss of the envelope and subsequent damage to the building interior. NIST does not have information regarding the church's occupancy at the time of the May 22, 2011, Joplin tornado. There were no reported fatalities or injuries at this facility, however.

Figure 3–90. Overview of damage at St. Paul's United Methodist Church and surrounding areas, with the estimated center line of the tornado damage path shown in red.

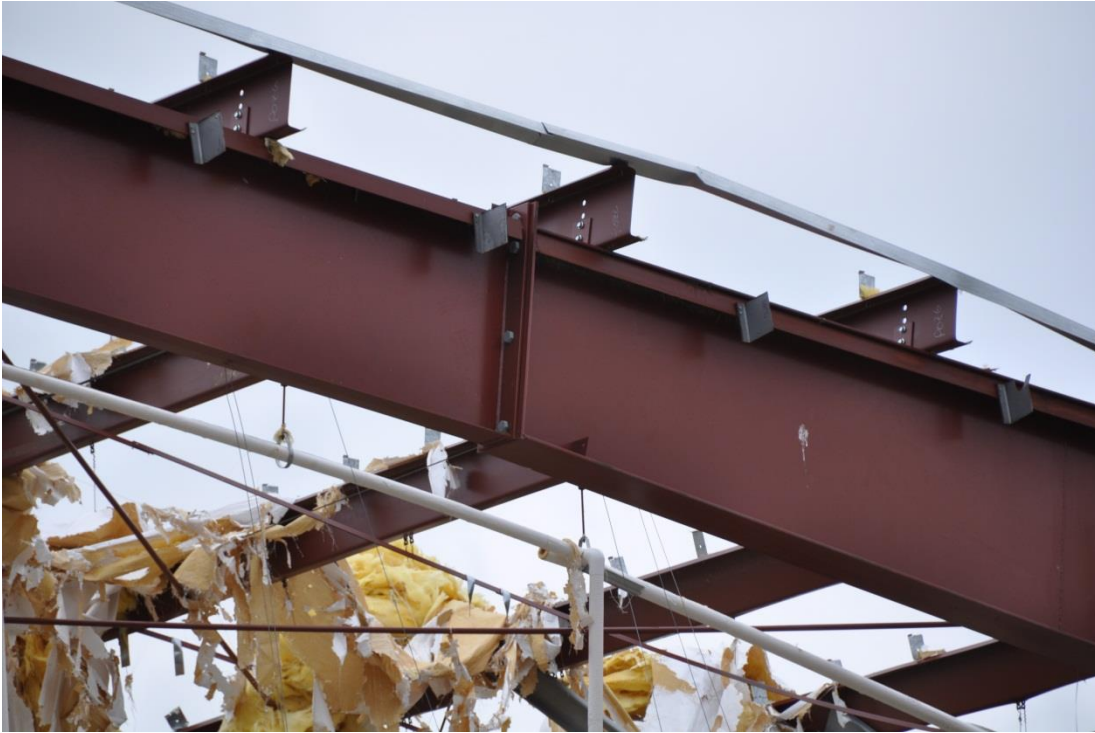
Figure 3–93. Tapered rafter sections with bolted connection and roof purlins of St. Paul's United Methodist Church.

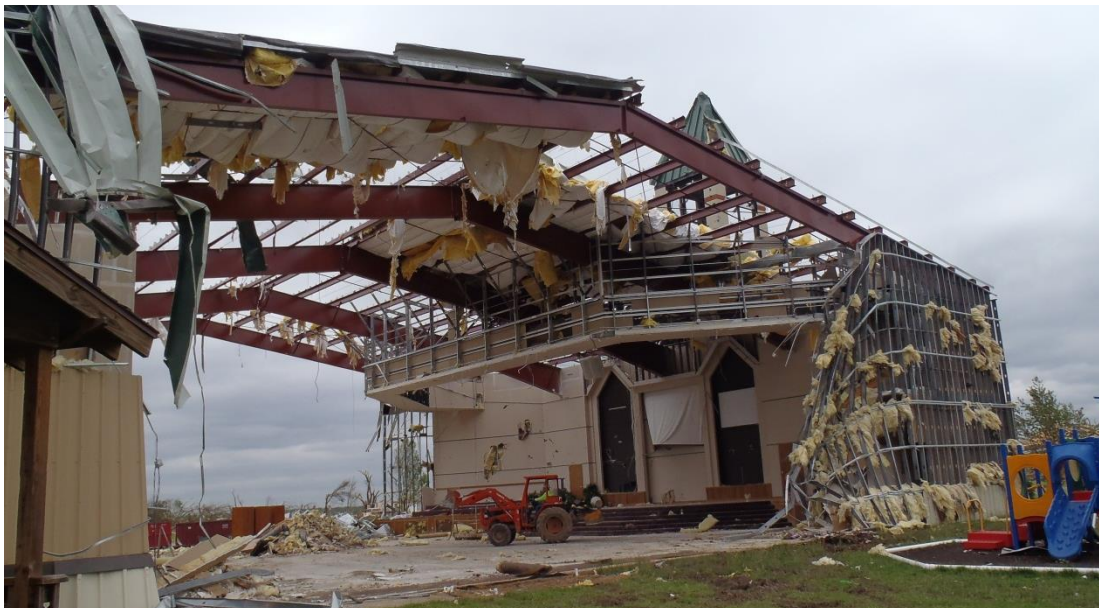
Figure 3–94. Damage to envelope of St. Paul's United Methodist Church.

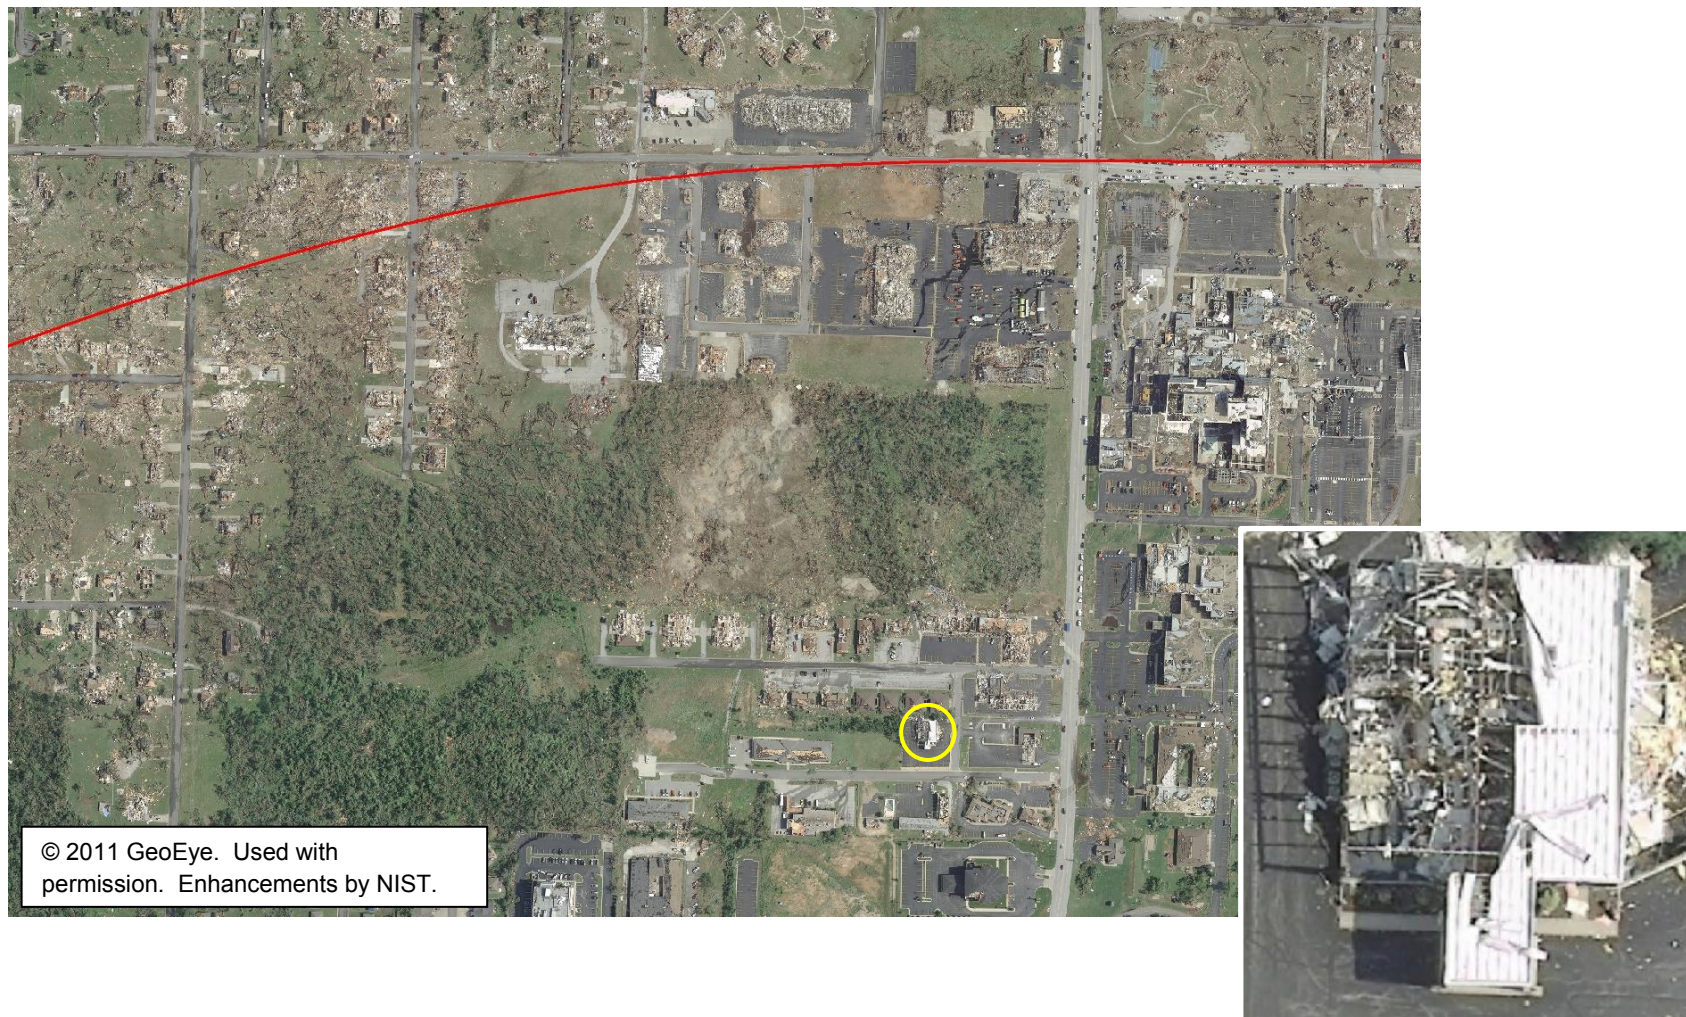
As most of the first story of this building was below ground (and shielded from significant wind effects), it was the pre–engineered steel frame second story that was most affected by the tornado. And similar to the performance of the Mass Hall building of St. Paul’s United Methodist Church (also a pre–engineered steel building), the second story of the Ramesh Shah building sustained significant damage to its envelope (disconnection and loss of all standing–seam steel roof decks, all synthetic stucco siding, and the window glazing and frames), but only limited damage to the MWFRS (braced primary rigid frames). The complete loss of the roof and wall envelopes likely relieved the pressure on the primary frame members, allowing them to remain standing during the tornado. As a result, the MWFRS of the building (pre–engineered steel frames) did not collapse, but the building sustained a complete loss of functionality due to the loss of the envelope and subsequent significant damage to the interior. NIST does not have information regarding occupancy at this building during the May 22, 2011, Joplin tornado. There were no reported fatalities or injuries at this building due to that tornado.

Figure 3–95. Overview of damage at the Ramesh Shah Ophthalmology Center, with the estimated center line of the tornado damage path shown in red.

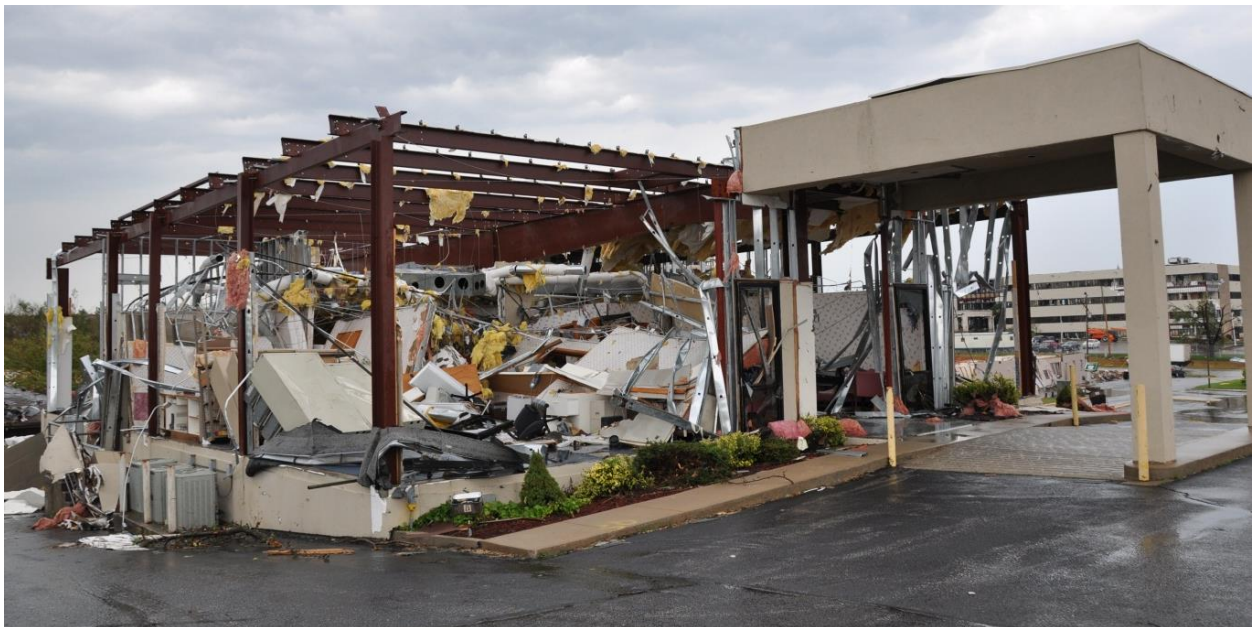
Figure 3–97. Ramesh Shah Ophthalmology Center viewed from the southwest.

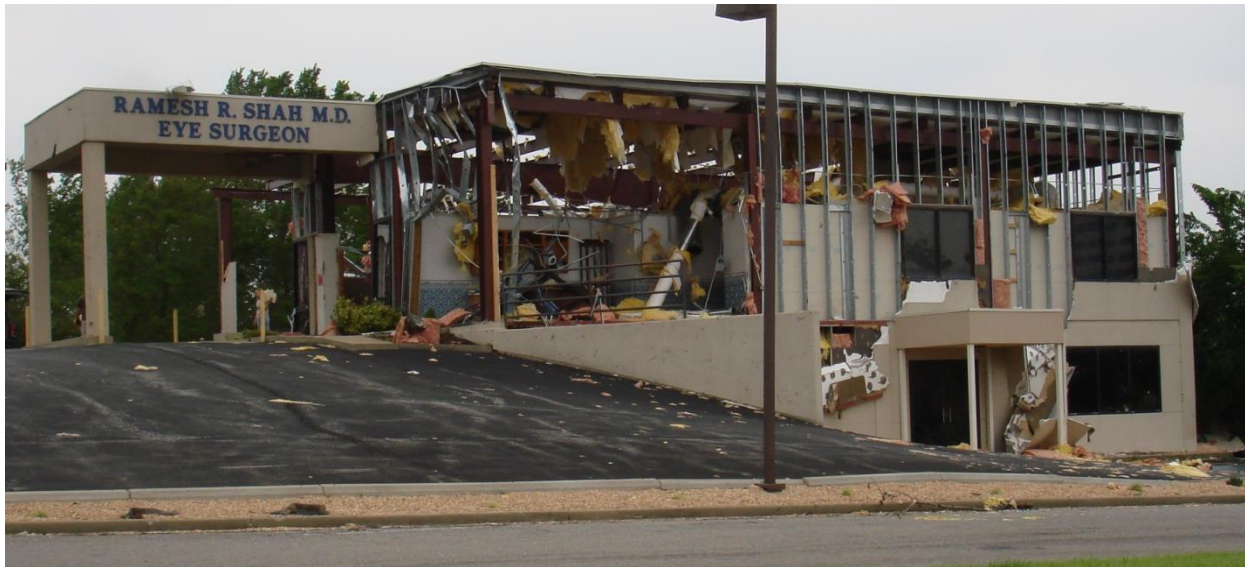
Figure 3–98. Ramesh Shah Ophthalmology Center viewed from the east–southeast.

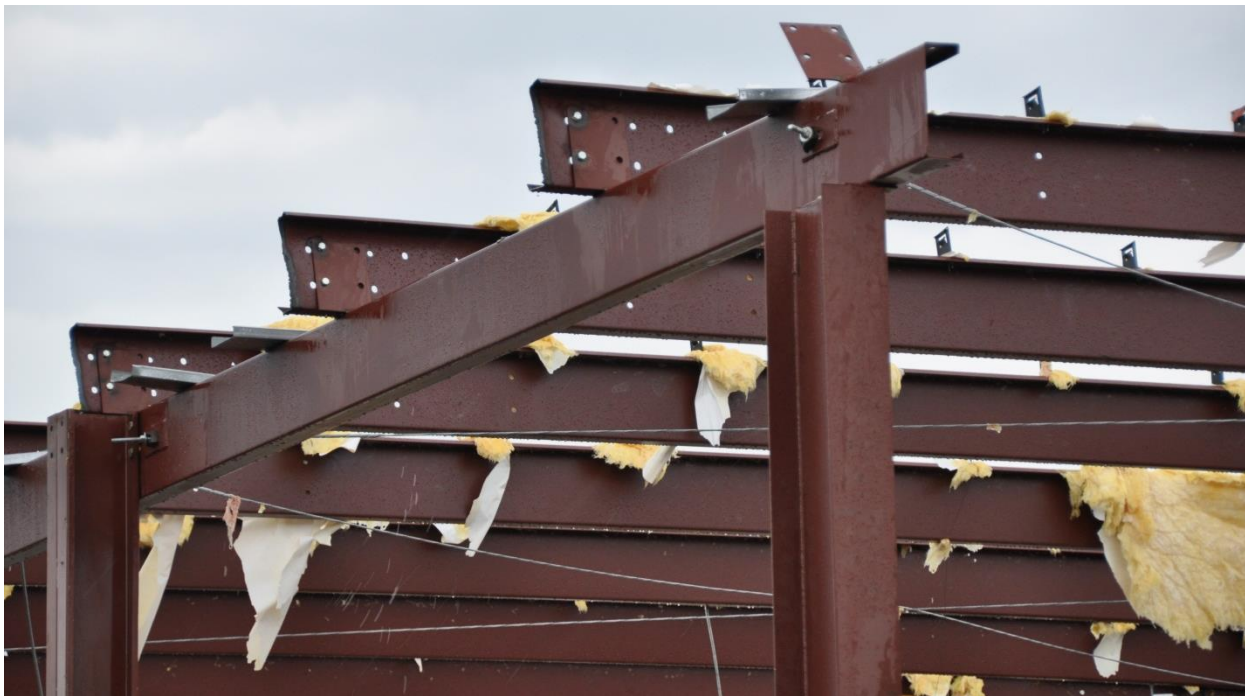
Figure 3–99. Close up view of the Ramesh Shah Ophthalmology Center showing connections and cable bracing of the pre-engineered steel frames

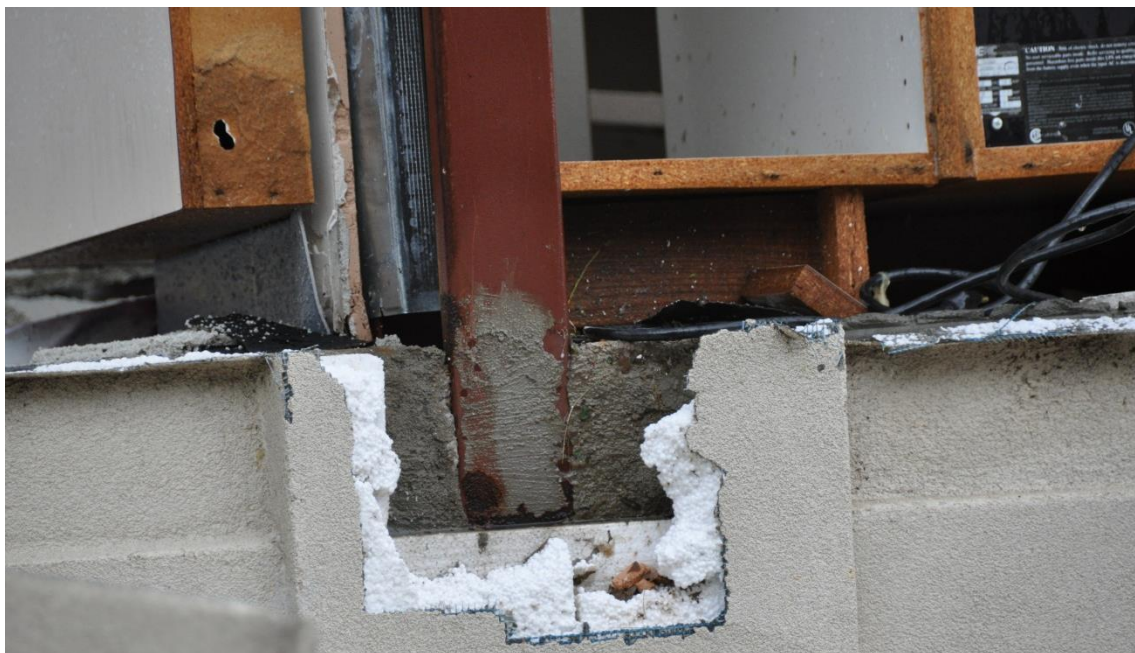
Figure 3–100. Close up view of the Ramesh Shah Ophthalmology Center showing connection between the pre-engineered steel frame with the concrete wall below

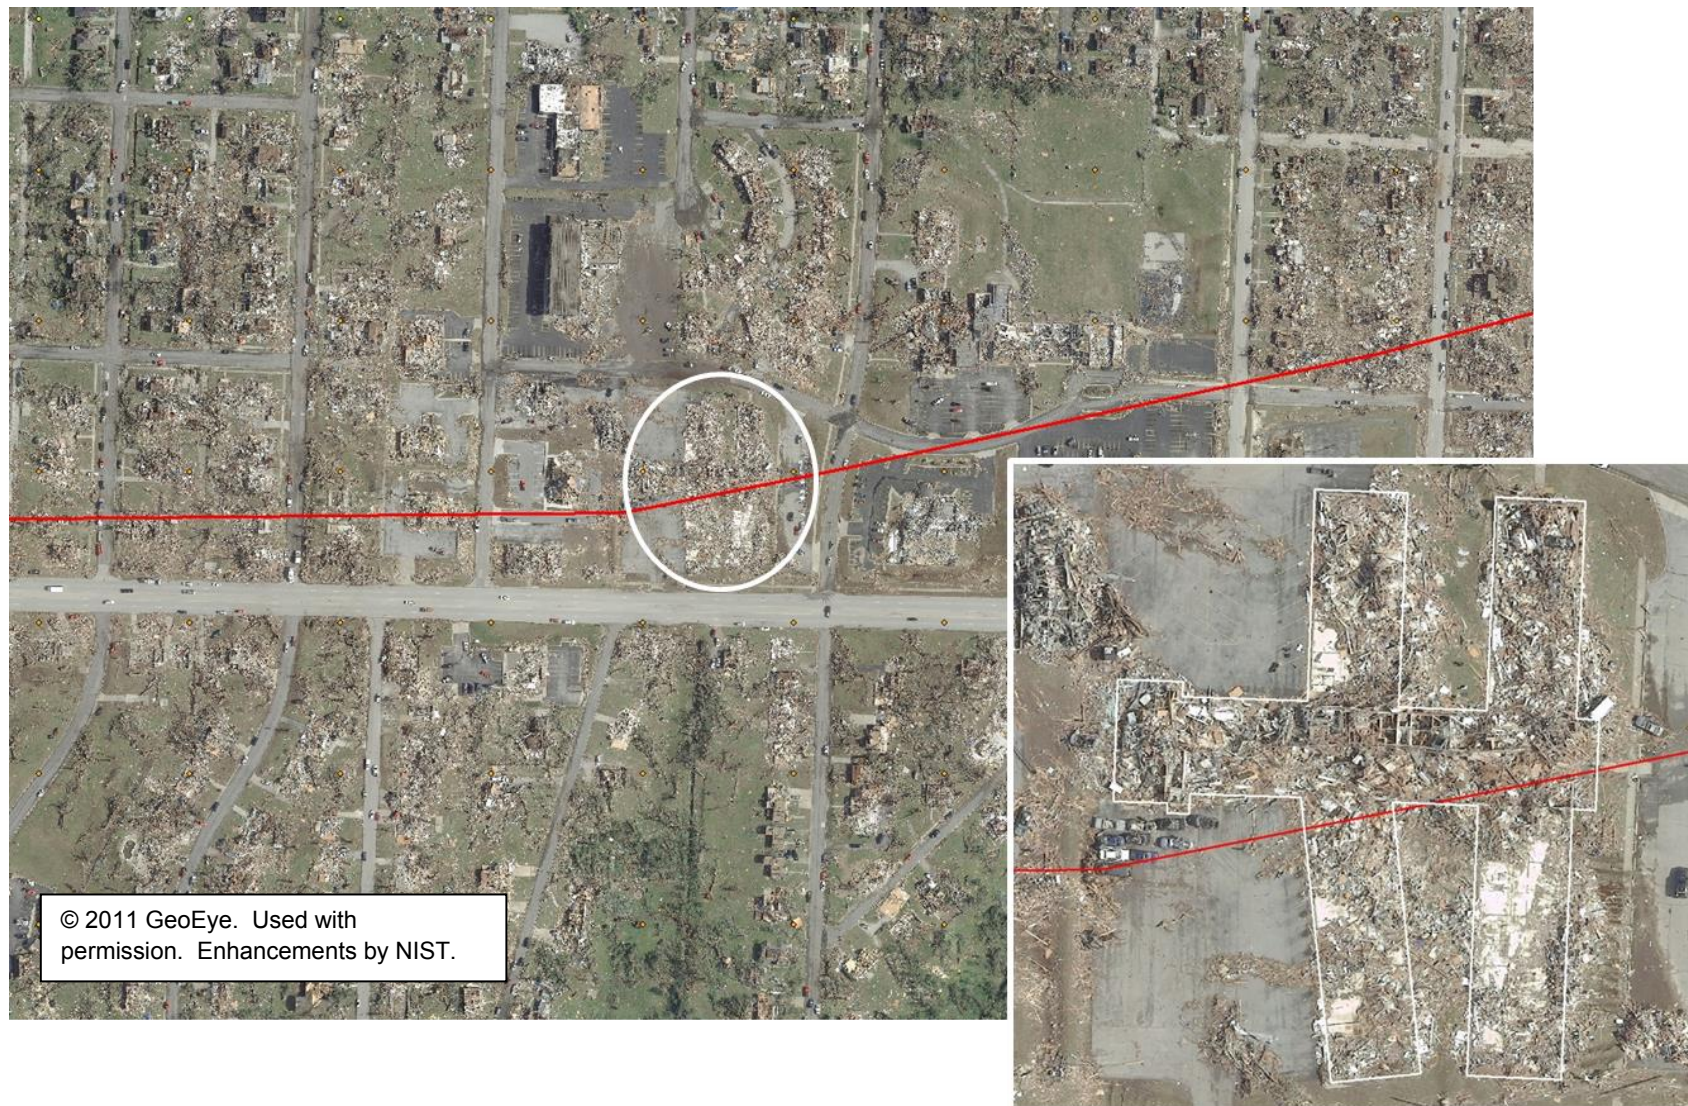
The Greenbriar Nursing Home, located at 2502 South Moffet Avenue (in the same vicinity as the Ozark Center and St. Mary's school) (Greenbriar), was at the center of the estimated tornado damage path (see Fig. 3-102). The facility was constructed in the mid-1960s, likely based on either BOCA BBC/1960 or 1965, and comprised a rectangular core section, oriented in the east-west direction, that was connected to four rectangular wing sections, oriented in the north-south direction. The maximum wind speed affecting this facility, estimated based on wind field model results for a point just to the west of the building, was about $165 \text{ mph} \pm 20 \text{ mph}$ (EF-3 range, see Fig. 3-103). The Greenbriar was directly east (downstream) of several residential neighborhoods that were totally demolished (see Fig. 3-1 and 3-102). Due to this juxtaposition, the Greenbriar Nursing Home was likely affected by significant amounts of wind-borne debris in addition to the strong tornado wind speed. The entire facility (core and four wing sections) collapsed completely in the storm.

Figure 3–102. Overview of the Greenbriar Nursing Home, shown in relation to the estimated center line of the tornado damage path (red line).

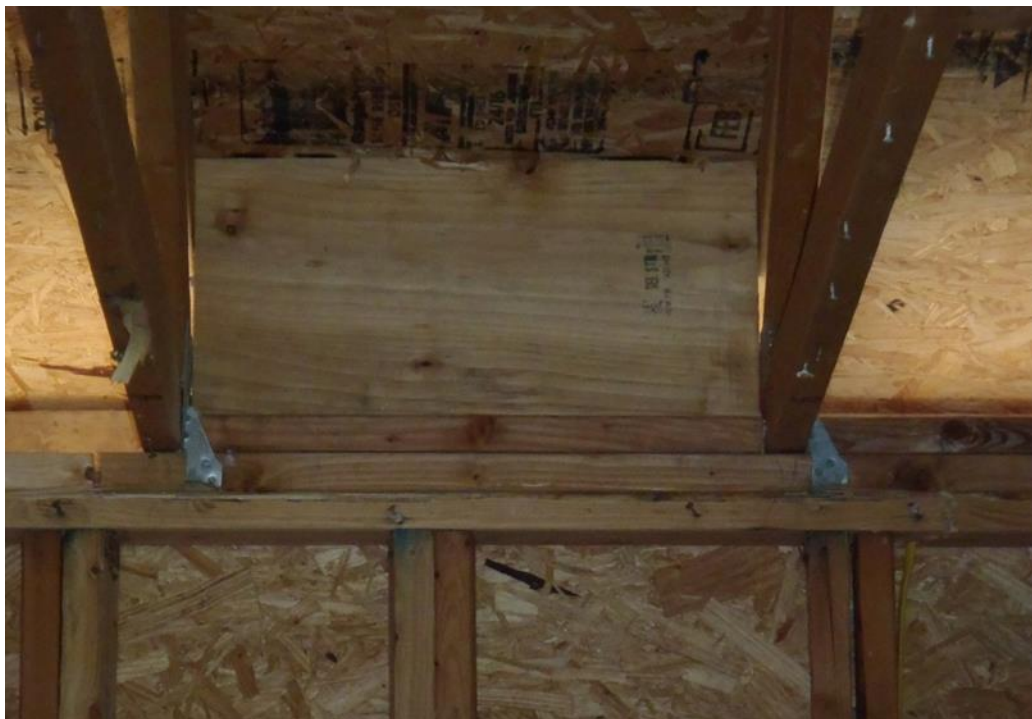
- Structural System:
 - Roof System: 2×4 wood roof trusses sheathed with plywood panels. The ends of each roof truss were connected to the top board of the double top plate of the third-floor exterior bearing walls with hurricane tie-downs (generally referred to as “hurricane clips,” see Fig. 3-109). Note that the hurricane tie-downs are installed on the inside of the wall while the sheathing that provides the transfer of loads to the wall studs is located on the outside of the wall. Hurricane tie-down manufacturer data suggests that this configuration reduces the effectiveness of the hurricane tie-downs by 50 percent unless straps are added to the inside of the wall framing to tie the double top plate to the wall studs.

Figure 3–109. Hurricane tie-downs connecting wood roof trusses to load-bearing wood-frame wall.

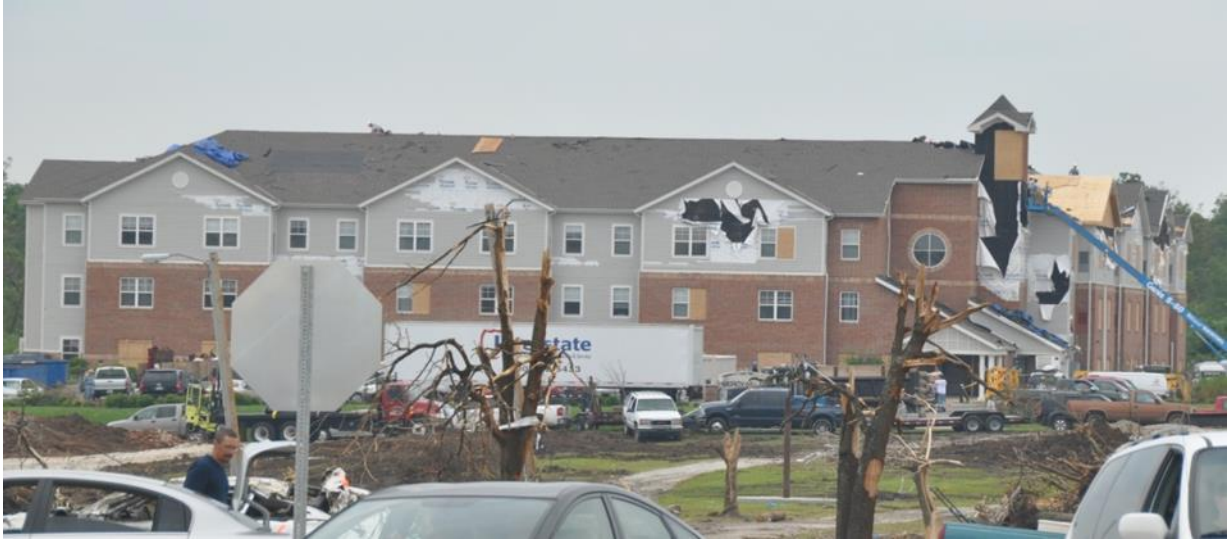
- Damage to window glazing on all sides of the building (both insulating glass and tempered glass), likely due to wind-borne debris impacts (there were windows near the broken windows that were not damaged, suggesting that wind pressure was likely not the cause of the broken windows).
- Damage to the exterior brick veneer, cement-board sidings (missing, broken boards), and roof covering (lost roof shingles).

Figure 3–111. Mercy Village Apartments, viewed from the north, with envelope damage (siding, window glazing, roof covering).

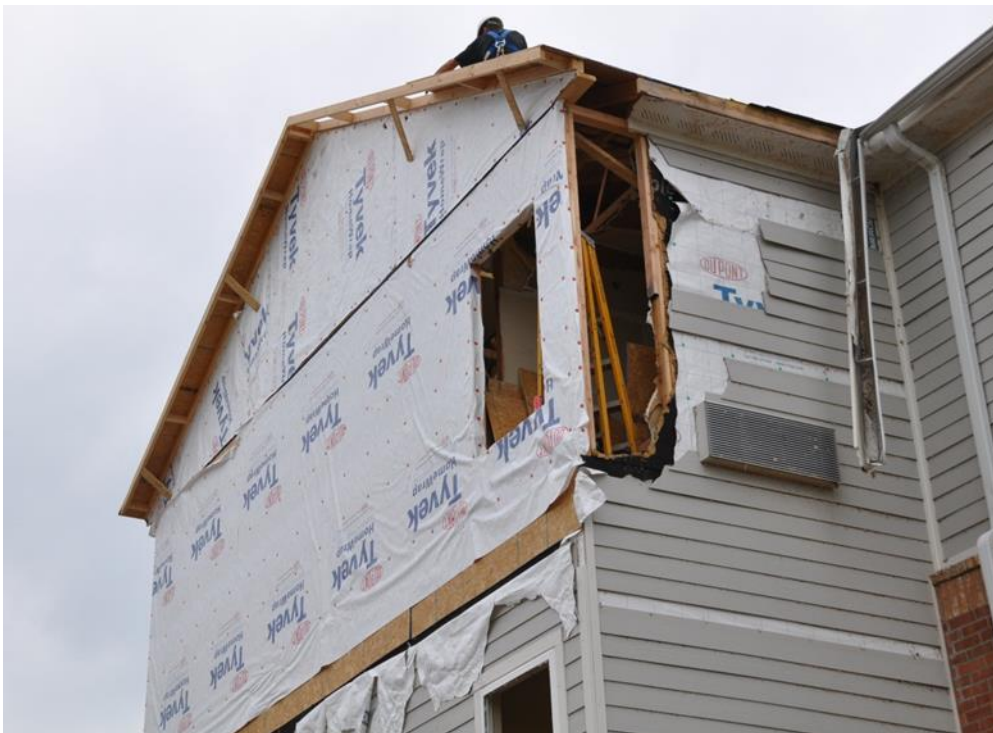
Figure 3–112. Damage to the building envelope of the Mercy Village Apartments.

- Loss of small sections of wall and roof plywood sheathing between the third floor and roof (see Fig. 3–112).
- Reported damage to the interior due to water infiltration where there were damaged windows.

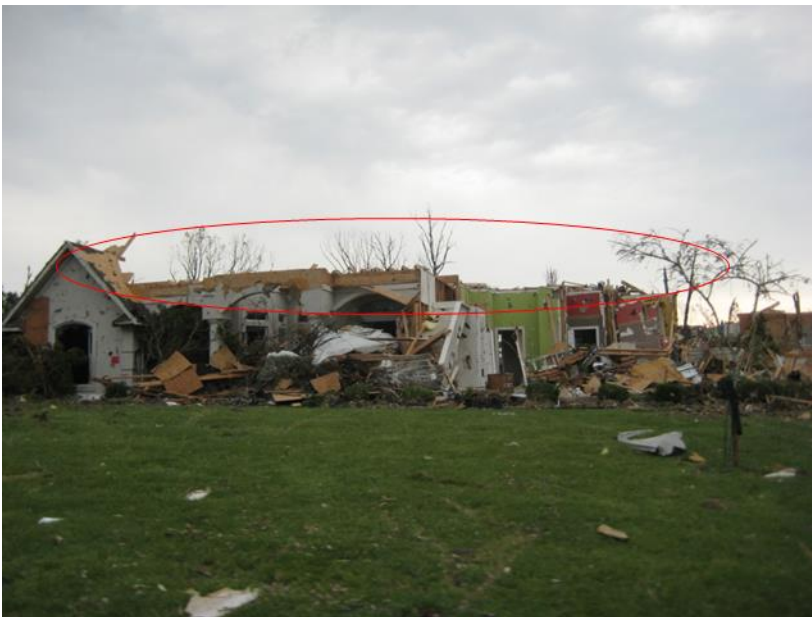
Figure 3-116. Typical roof-to-wall connection damage.

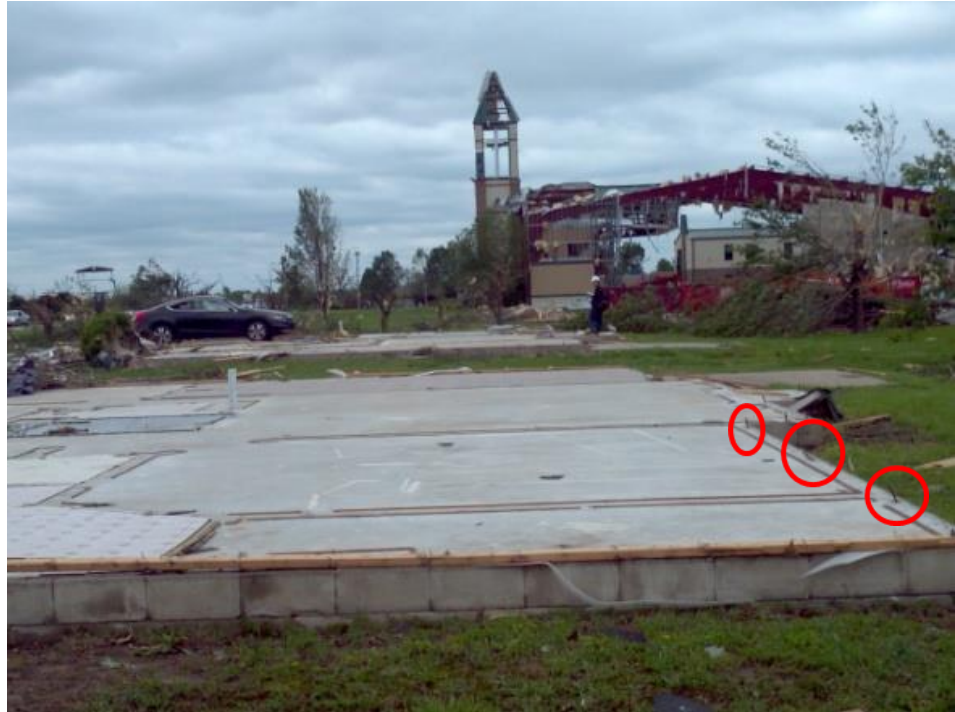
Figure 3-117. Typical wall-to-foundation connections.
